Streams and Rivers by Watershed

nohomish County contains parts of three major watersheds:

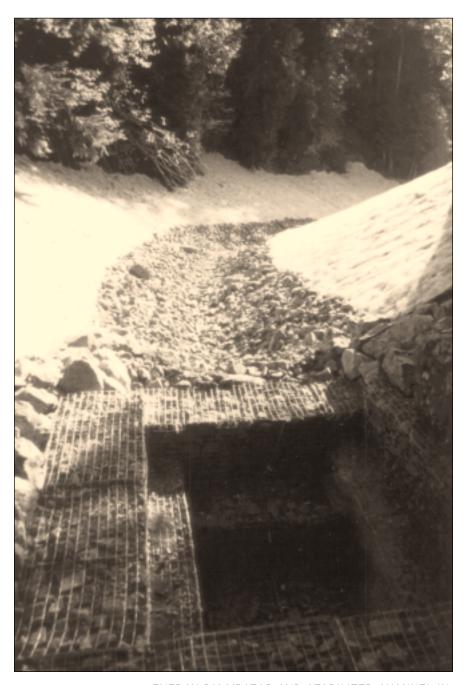
ENERGY DISSIPATOR AND STABILIZED CHANNEL IN HILTON LAKES DRAINAGE, PHOTO BY JOHN ENGEL

High turbidity is a problem in these streams that drain the hillside. Sediment loading comes from runoff from developed properties channeled into steep ravines with erosive soils. Snohomish County recently completed a project in the Hilton Lake Drainage to stabilize a channel in a steep ravine and dissipate storm runoff into the ravine to halt erosion. The County is working with the Marshland Flood Control District to identify and mitigate erosion problems.
