**Northwest Stream Center
Wetland Boardwalk**

Project Update October 31, 2015

Marian Hanson, MLA
Landscape Design
Phone 425-742-6244
Cell 425-218-3353
marianh222@hotmail.com

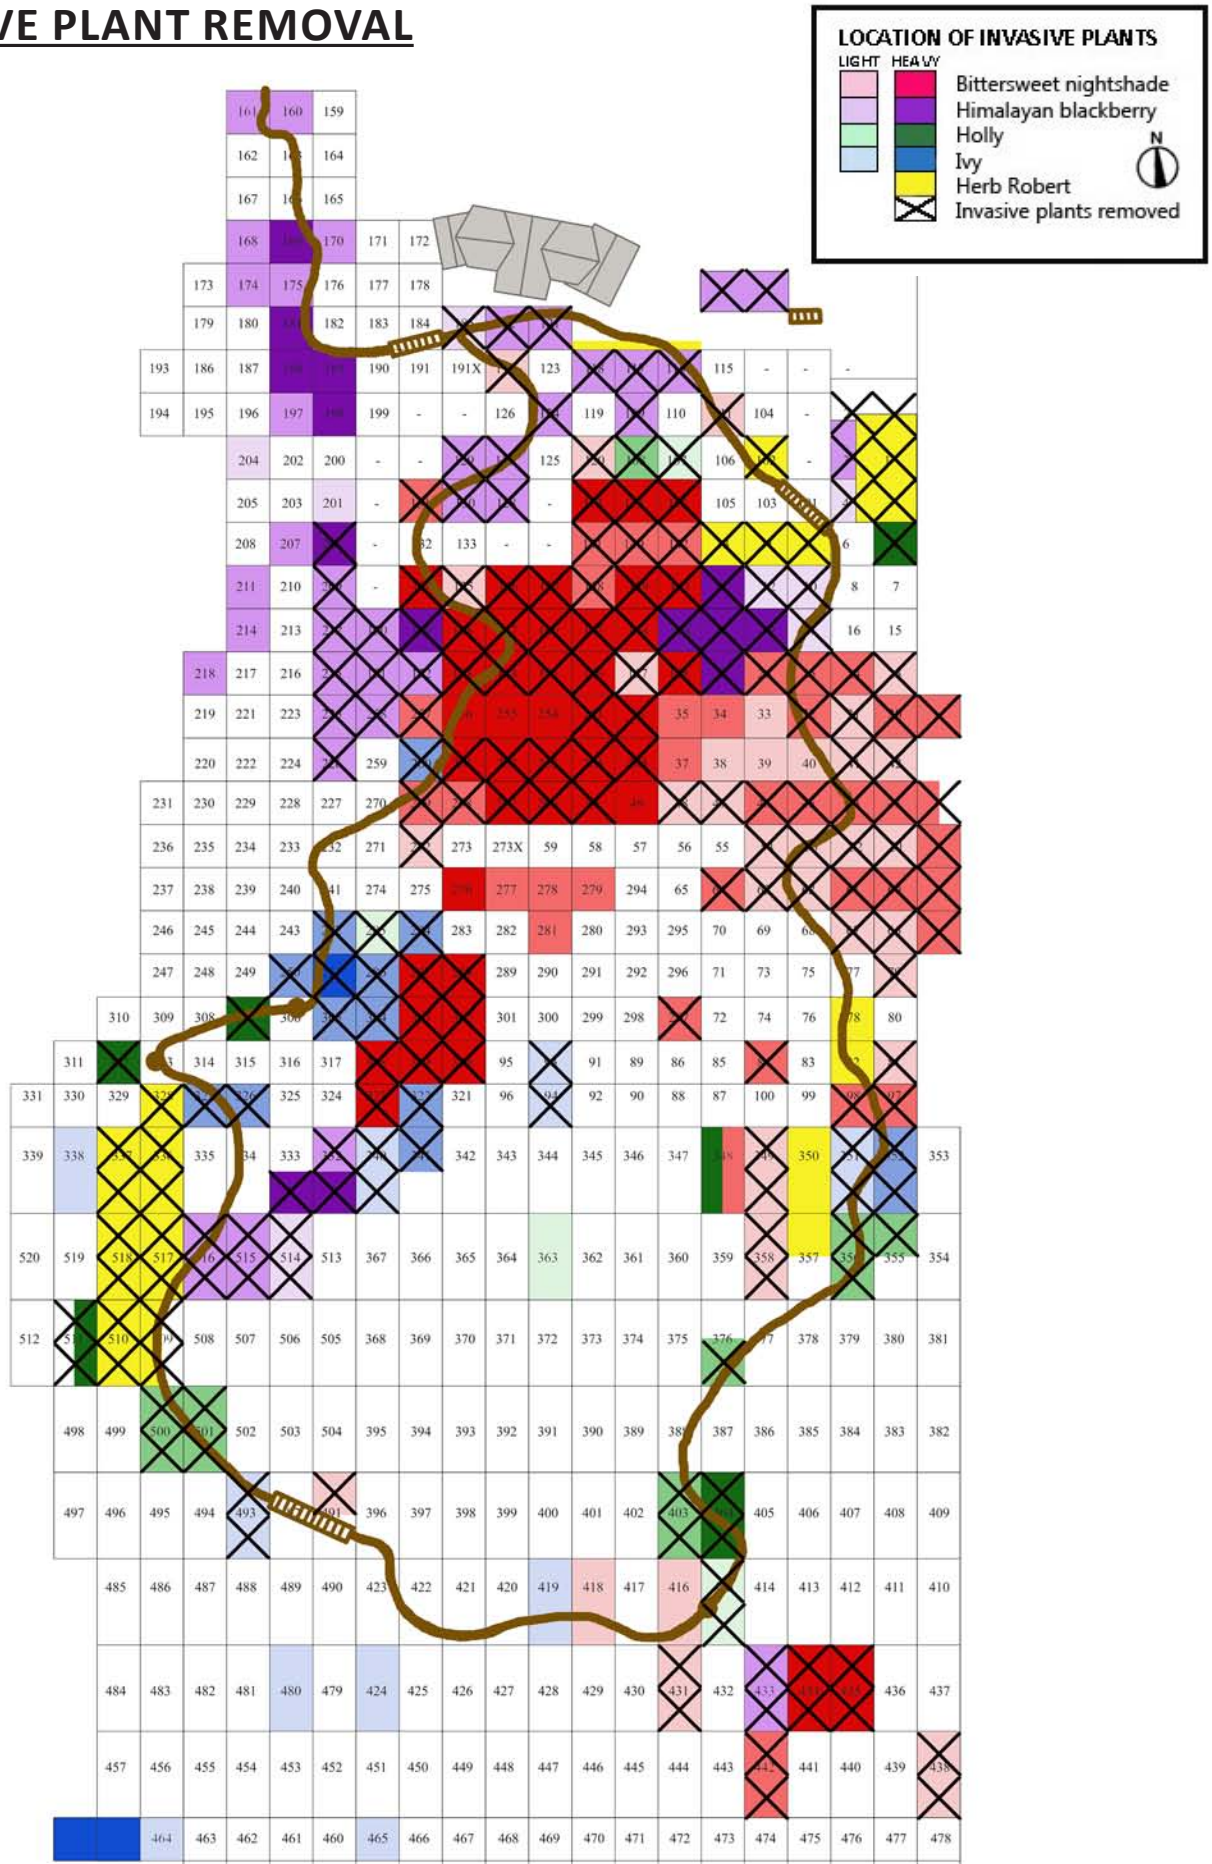
Fig. 2.1: Location of Invasive Plants (reed canary grass not included) from 2012 map, field notes & recent observation (Hanson 2015) Page 2

As I mentioned in the last report, the invasive plants have spread since I did the original site inventory, which is why each successive map of invasive plants seems to have more sectors marked. Their locations can be seen on the map (fig. 2.1). Here sectors are marked with the predominant invader, although others sometimes share the same space. The following is a summary of what I estimate we have removed. Sectors cleared of invasives have been crossed off on the map.

I have marked the most prolific **herb-Robert** areas in yellow on the map (fig. 2.1). Even though it has been removed from these sectors (some more than once) it is robustly seedy and shows up quickly. These areas in particular will need to be revisited 2-3 times a year until the herb-Robert seed banks are depleted.

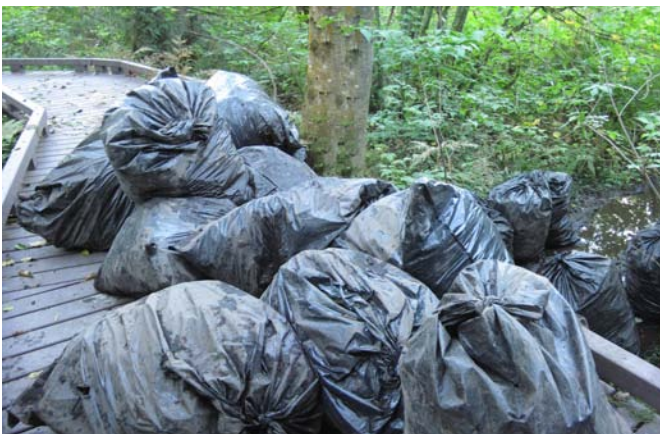
Nightshade removal (left) can make a muddy mess on the boardwalk. Ivy on SW neighbor's fence (right) can spread easily to forest & creek.

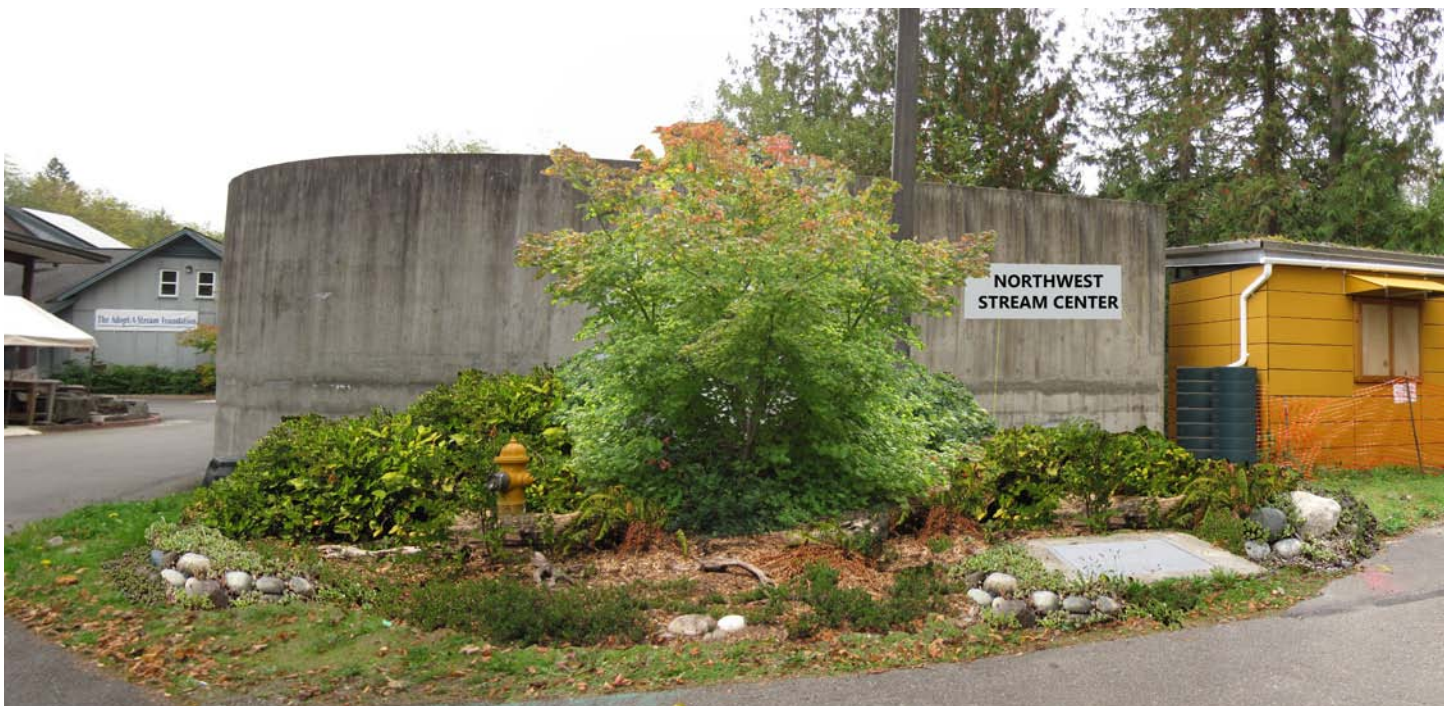
Proposed garden for the front entrance would replace some of the weedy grass with native plants.

It would be nice to replace the weedy grass out front with a Pacific Northwest garden. Vine maple makes a good choice for a native tree here as it isn't large or aggressive, grows well in part shade to sun conditions, and is lovely with fall color. The space could take two to three trees if you want to block most of the view of the concrete wall, but the NWSC sign would need to be moved to be seen. The garden can also easily be smaller with more grass in front, or all the grass can be replaced with a larger patch of sedum and rocks in front. The fire hydrant and utilities located here would need to remain visible and accessible. While tall Oregon grape would do well here, I would not plant it in this garden as it spreads by tough rhizomes and the leaves are prickly like holly. This would be a problem for the fire hydrant and utilities access as well as the pedestrian and vehicle traffic. On the following page is a list of plants that would work well in this garden (Table A).

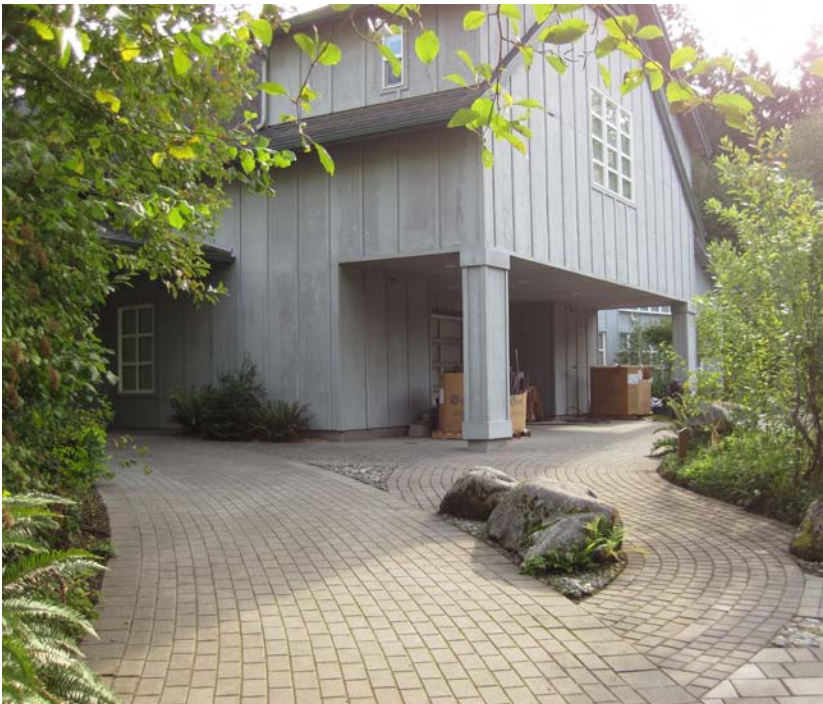
Most of the brick patio has been cleaned, weeded and resanded. I have not been able to do this to the front under the front overhand as the excess construction debris from the boardwalk has been piled there. It was just removed, so now I can finish this. Larry’s crew repaired/recented the brickwork near the southeast door along the edge of the fern garden as it was sinking here. The southeast brick walk near the meadow is also sinking where the interns wash out buckets from the pond. I have suggested they find a better place to do this rather than on the brick patio, as this is set in sand and they undermine the bricks when they do this regularly (see photo below). It also leaves a layer of duck weed on the patio which is unsightly. This practice needs to change before we can effectively repair it. Ten feet east from there we have a few bricks that need to be reset where a tree root has raised the bricks. Also mud and water accumulates in the east corner of the brick walkway next to the northeast parking lot. The AAS employees used to park the trailer here so the walkway has been damaged (see photo below). Thankfully, they have a new parking space in the asphalt lot near the Plant Nursery bridge. This area of the brick walkway should be raised slightly and sloped towards the trench drain to the east. I would also suggest when repairs are made to the brickwork, that the gravel layer be made thicker and the sand layer thinner to help support these sinking areas. The brickwork needs to be finished ASAP as this is a tripping hazard for visitors.

Above - The front patio and margins look much better cleaned and weeded. The construction debris seen above was just removed.

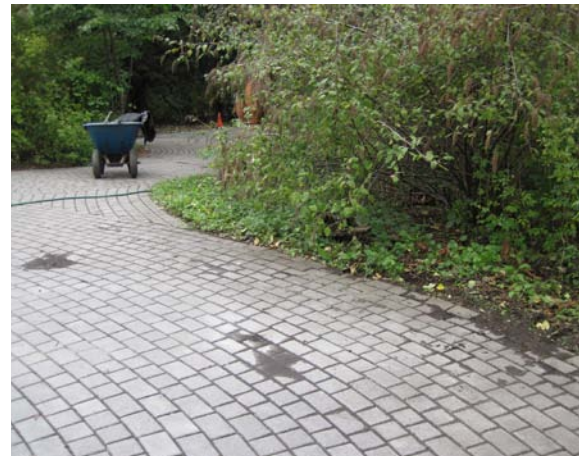
Top right - Mud accumulates in the areas where the bricks are sinking from washing buckets.

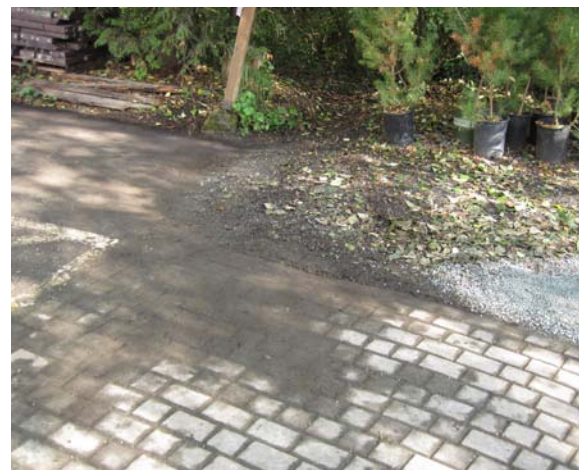
Lower right - This area collects mud and water where the brick path has sunk under the weight of the AAS trailer and cars that park over the line.

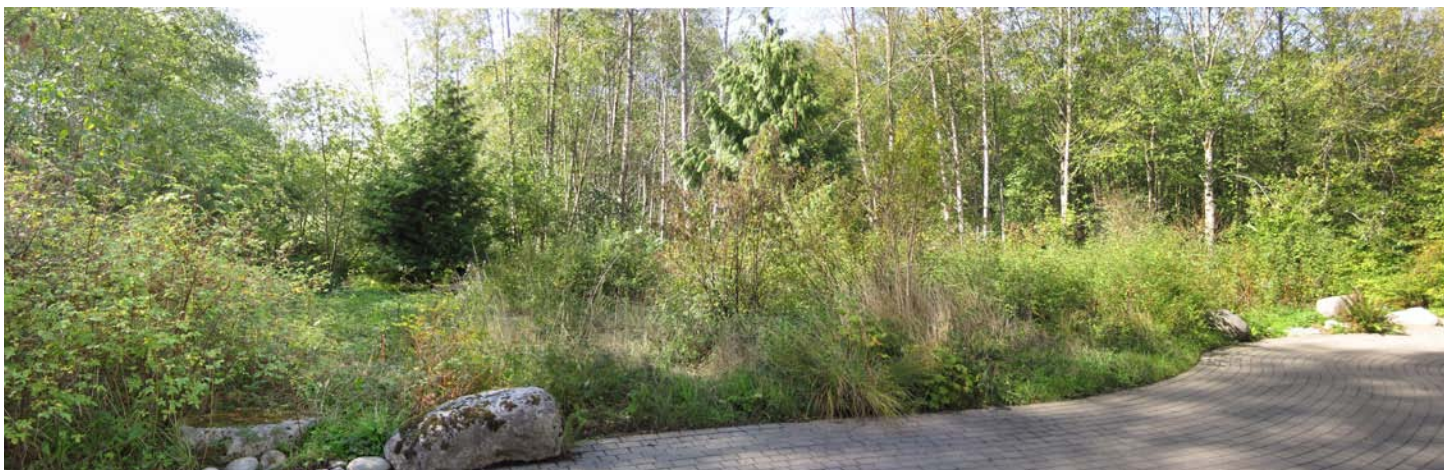
The Front Meadow is surrounded by many shrubs and trees beneficial to the wildlife found frequently here. The shrubs have taken over, however, so some will be selectively removed to retain the view from the patio and boardwalk.

I plan to limb the trees up a little higher, remove a few additional shrubs to open the view, remove some buttercups and reed canary grass to have space for more sedges and other wetland meadow plants, and add some wildflowers to the higher/drier meadow closer to the patio. We need to retain the features and plants that are providing the habitat to the wildlife mentioned above, and continue to consider their needs with the additional plants. I have provided plant lists at the end of this section keeping that in mind.

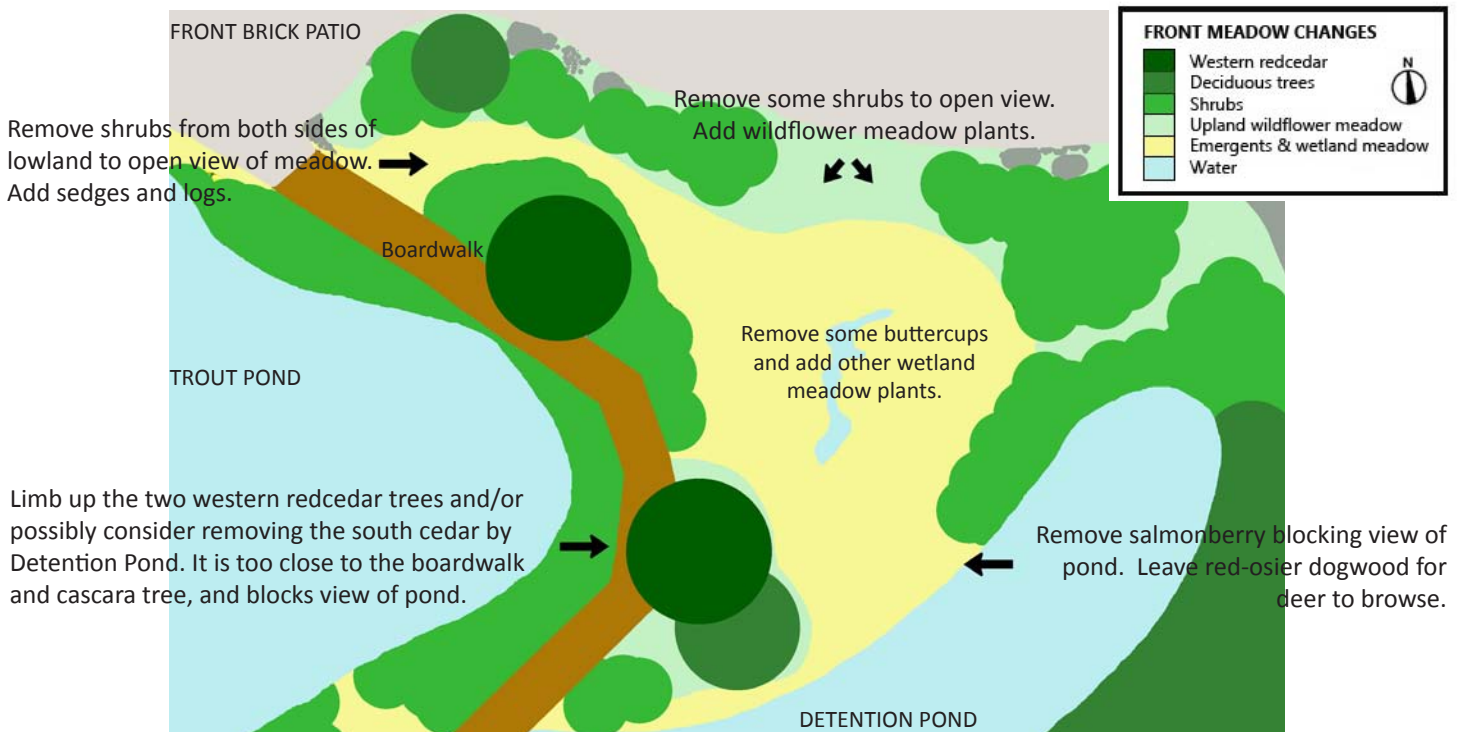
Figure 3.2: Diagram of Front Meadow Changes

The diagram (fig. 3.2) shows my plan for the Front Meadow. By strategically removing shrubs, habitat is retained for the garter snakes, butterflies, pollinator insects, song birds, hummingbirds, owls, and other wild-life found in this area, while thinning out shrubs that are taking over the meadow. In the following (Tables B and C), I have compiled a list of plants for butterflies and hummingbirds. The wetland meadow plants can be added to the emergents and wetland meadow area (in light yellow) on the diagram. The wildflower meadow plants would enhance butterfly and hummingbird habitat for the upland meadow area (light green). The list of shrubs and trees for butterflies and hummingbirds would be helpful to refer to so we don't remove too much of the habitat already present for them while removing shrubs from the meadow.

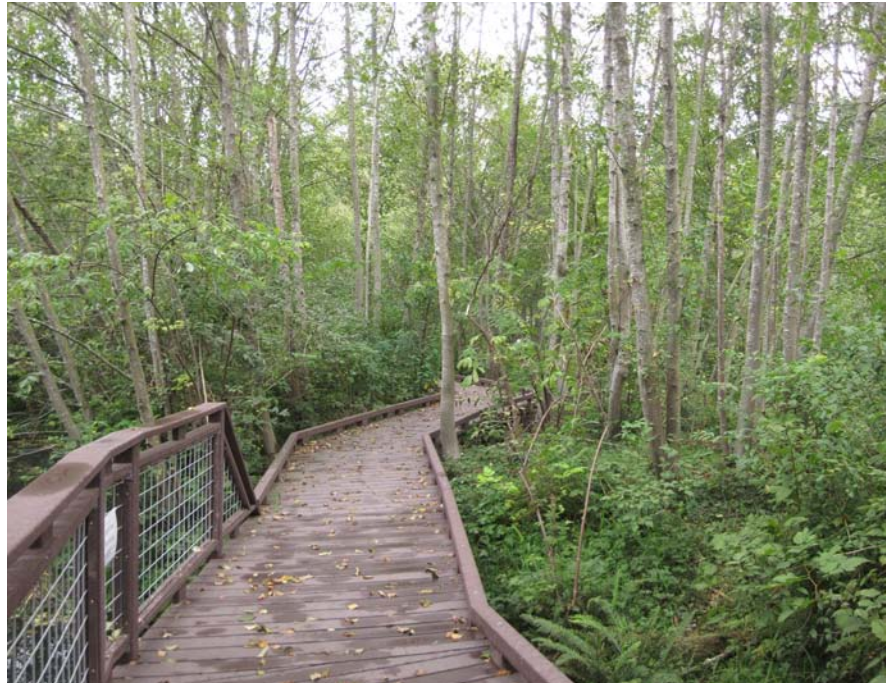
The Isthmus at right is growing beautifully with the addition of the shrubs, ferns, ground covers, woody debris and mulch. This photo (looking west) shows the area where the ducks like to cross to change ponds. Larry did a great job keeping the boardwalk out of the way here for them.

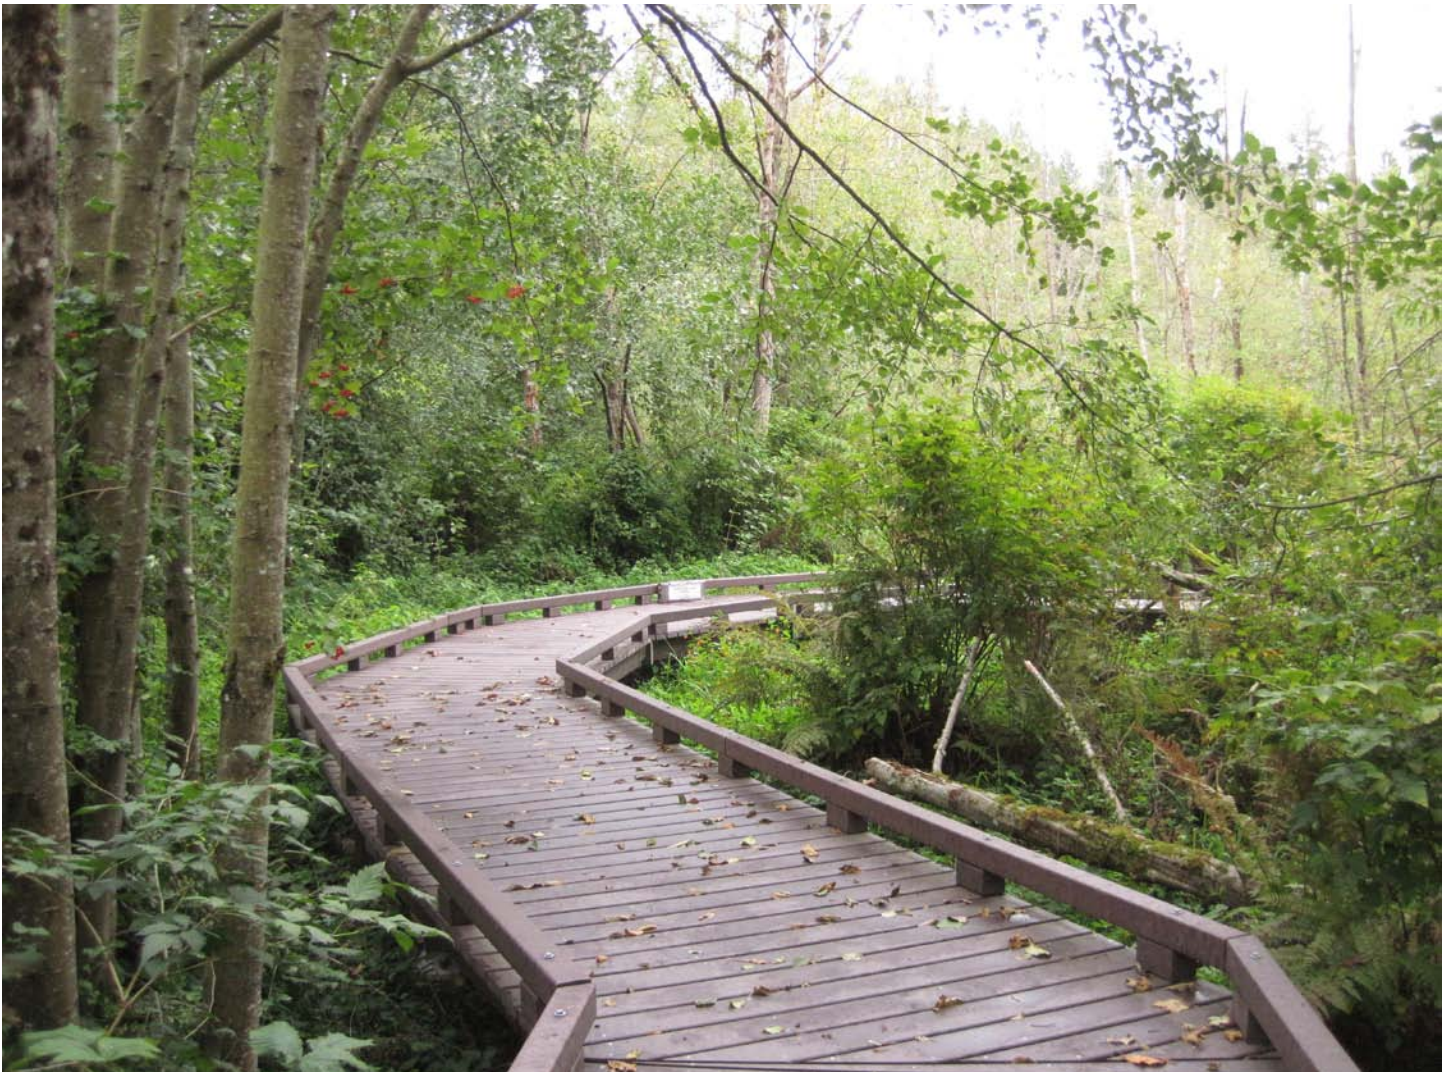
In addition, water flowing in a couple of places under the boardwalk here has some potential to erode the pier blocks holding up the boardwalk. I have done what I could to lesson the pressure, and have mentioned it to Tom, Larry and the AAS ecologists who need to monitor it and possibly improve the situation further, as this is their area of expertise.

This beautiful view was once covered with bittersweet nightshade. Here the Headwater Stream Viewpoint will be added to the boardwalk if funded.

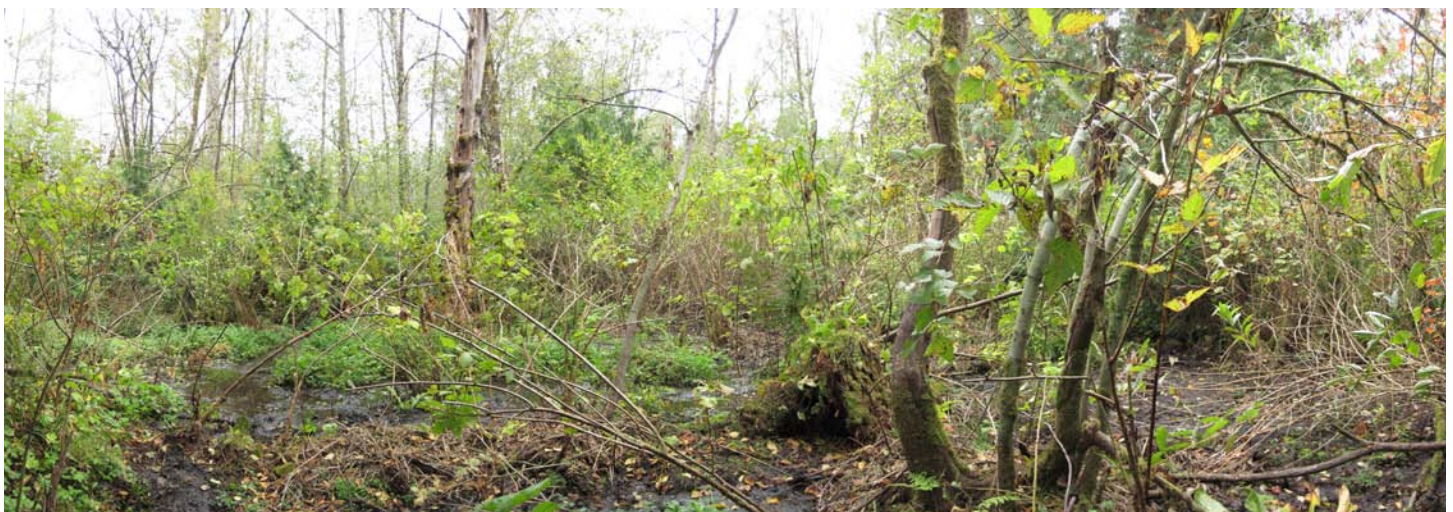
Here is a small portion of the area mentioned above where we recently removed nightshade. Just beyond view of the boardwalk, nightshade completely covered the plants (which is why the vine maple at right is hunched over). By next year, the nightshade here would have spread to the point of being quite obvious to visitors standing on the boardwalk.

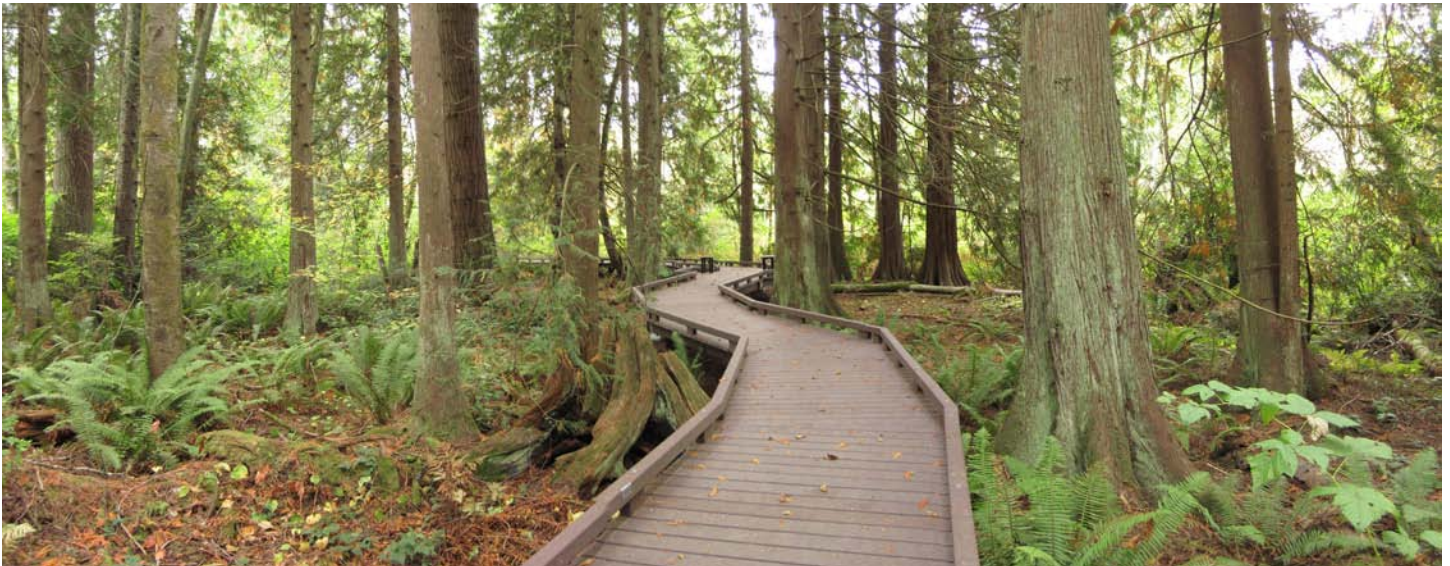
Under the large western redcedars, the Cedar Cathedral area (above) and the Salmon Arena (below) are both open and fairly dry.

The Cedar Cathedral is a wonderful place to listen to song birds and the gentle flow of North Creek while sitting on the beautiful benches handmade by Larry. Under the canopy of large western redcedars, this area hosts an understory of salal, sword ferns, and native blackberry, with a backdrop of vine maple. Once denuded by unauthorized camping activities, it is nice to see the false-lily-of-the-valley, moss and salal creeping back into the space. We replanted the area with additional salal, sword ferns, false-lily-of-the-valley, red huckleberry and bunchberry on the ground, and in woody debris hummock areas we built after removing nearby invasive holly and ivy. We also planted additional vine maple, small western redcedar and Indian plum in the background perimeter. With the dry summer, it was a chore watering here by myself so I decided to finish planting during the wetter season. I would like to add a few red huckleberry, evergreen huckleberry, salal, and sword ferns to the bare spots that are left.

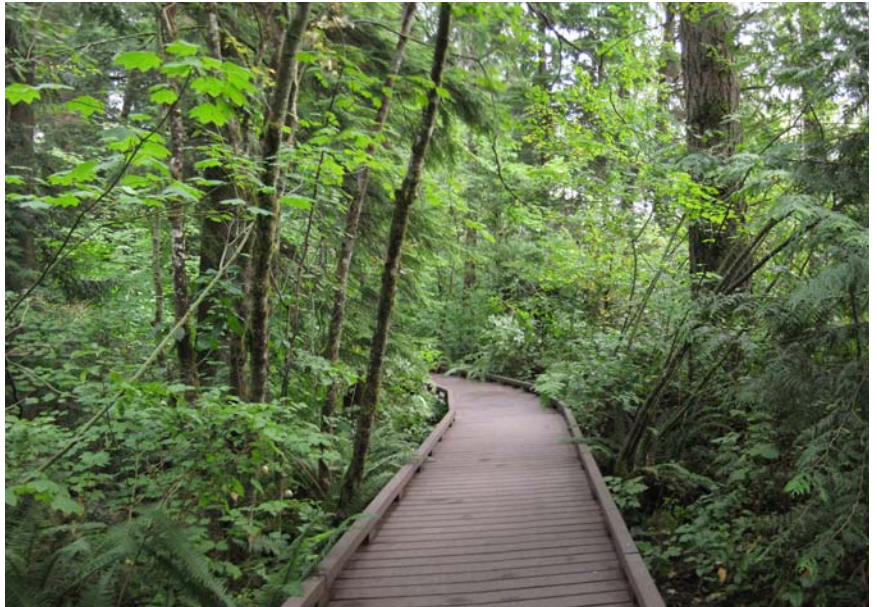
The Southwest Vine Maple Forest is lush and cool in the summer.

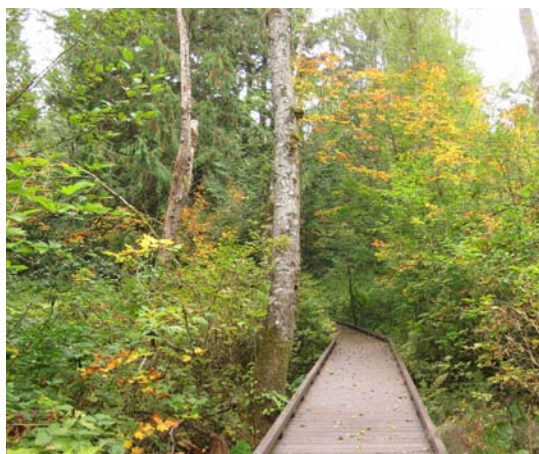
I added a few common rush, branches and a skunk cabbage to the **Frog Pond**, but for additional ideas to enhance amphibian habitat, please see my NWSC November 2014 Update. To the mound (above) which used to be a campsite and garbage pit, I added sword ferns, Indian plum, tall Oregon grape, piggy-back-plants, mulch, logs and other woody debris. I added salmonberry, vine maple and more woody debris to the social trail just south of this mound (right of photo above) and woody debris, mulch, ferns and shrubs to the “mud stream” areas at the boardwalk curves. In the photo (left), this forest is lovely with its colorful vine maple. It

does, however, have a few red alder hazard trees near the boardwalk to cut down, also ivy and bittersweet nightshade in the north to remove.

LOCATION & PROJECT	LEADER CONTACT		
	LARRY	MARIAN	TOM
<p>Wetland Forest East of Frog Pond: Evaluate hazardous red alder trees near boardwalk for possible removal (consult with James Yu who is a Certified Arborist) Cut down hazardous red alder trees & haul out to shred pile Shred excess woody debris</p>	X X	X	X X
<p>Forest Lantern Viewpoint: Have James Yu evaluate loose dead tree next to bench for removal Prune rotten spruce branches above bench at viewpoint & haul out Shred/use excess woody debris</p>	X X	X	X X
<p>Downed Tree Swamp: Remove invasive plants (nightshade, herb Robert, Him. blackberry) Add sedges, piggyback plants & sh. ferns to ephemeral ponds by BW Selectively prune branches from downed cedar tree top & shred</p>		X X X	
<p>East Central Meadow: Remove tall rotting dead tree east side boardwalk north of stream Remove remaining invasives (nightshade & herb Robert)</p>	X professionals	X	X

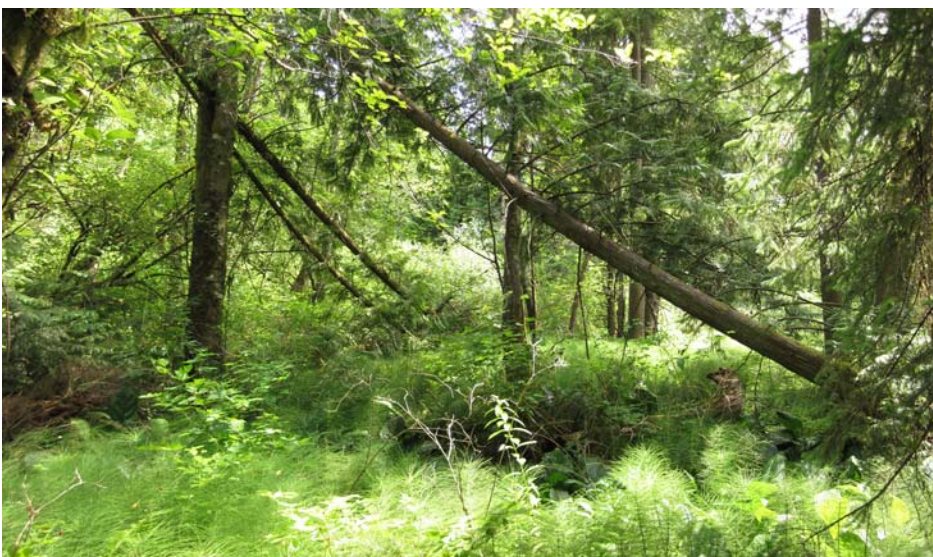
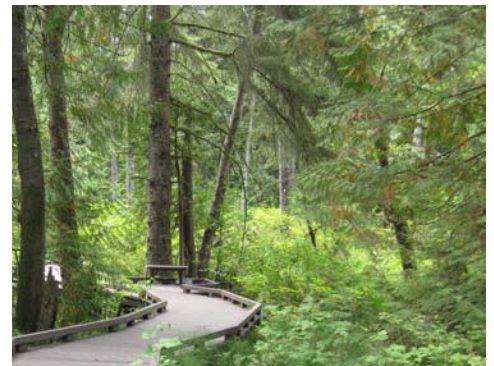
both animating the place. Larry built the boardwalk’s viewpoint area (photo above) with seating to watch the activity. However, there are rotting branches and a loose tree just above and behind the bench that need to be removed. I removed the Himalayan blackberry and holly on the squirrel mound, and a significant patch of bittersweet nightshade, both to the southeast (beyond center of left photo). We also planted skunk cabbage starts in the low mud.

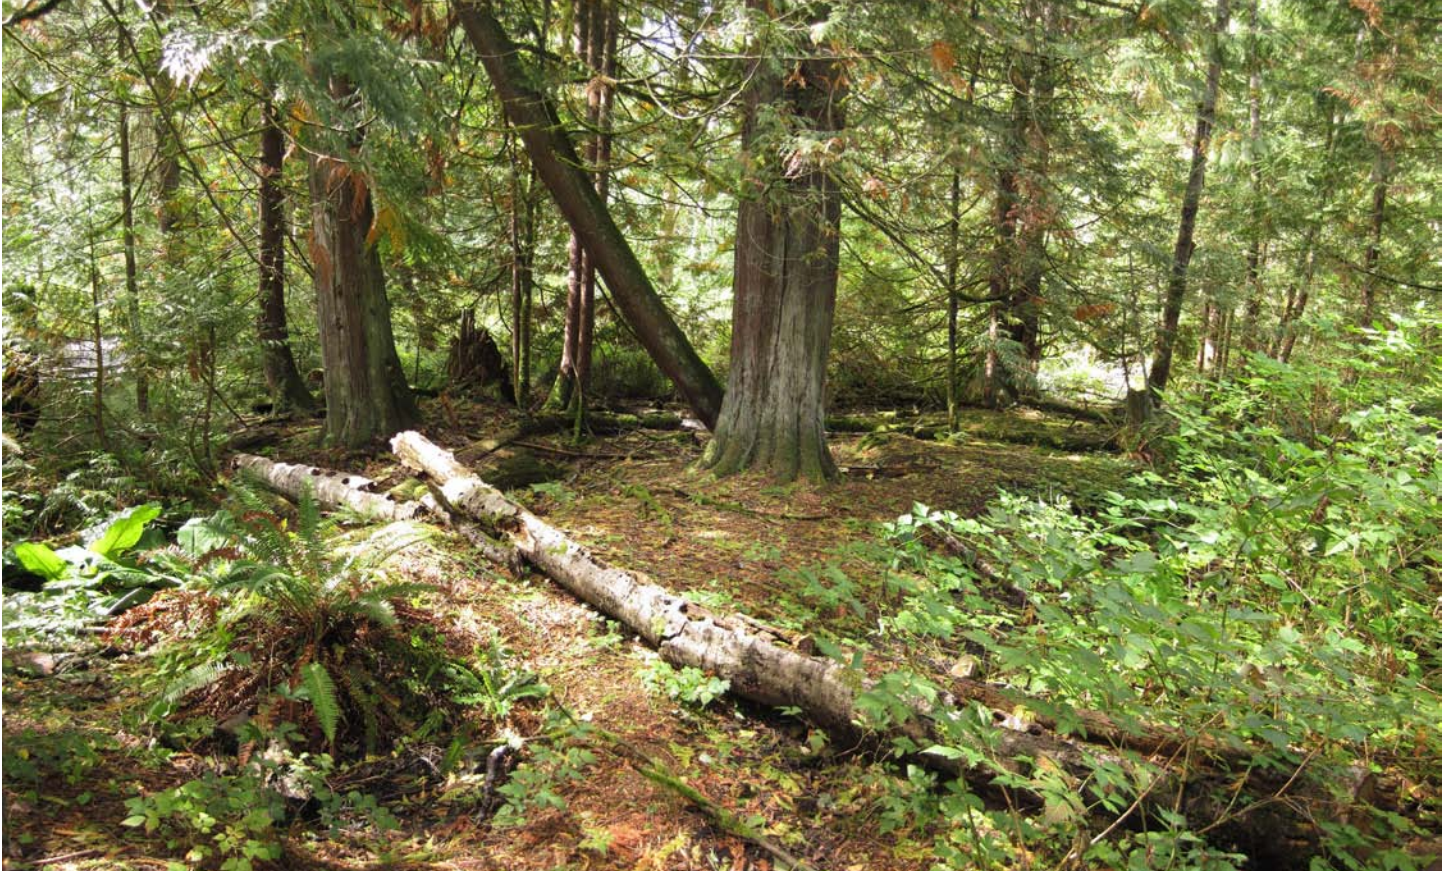
Once a large campsite with a sprawling lean-to, the ground here was denuded over time from the activity (since my original inventory of 2011). Now the area is looking better.

Since we cleaned up and planted this area, it has improved. We added sword and shield ferns, red huckleberry and bunchberry on logs, skunk cabbages and sedges in the wet muddy areas, and covered it with woody debris and mulch to encourage the false-lily-of-the-valley groundcovers to return. I would like to add a few more ferns, red huckleberries, evergreen huckleberries, bunchberries, Indian plum, sedges, and small skunk cabbages in the spring.

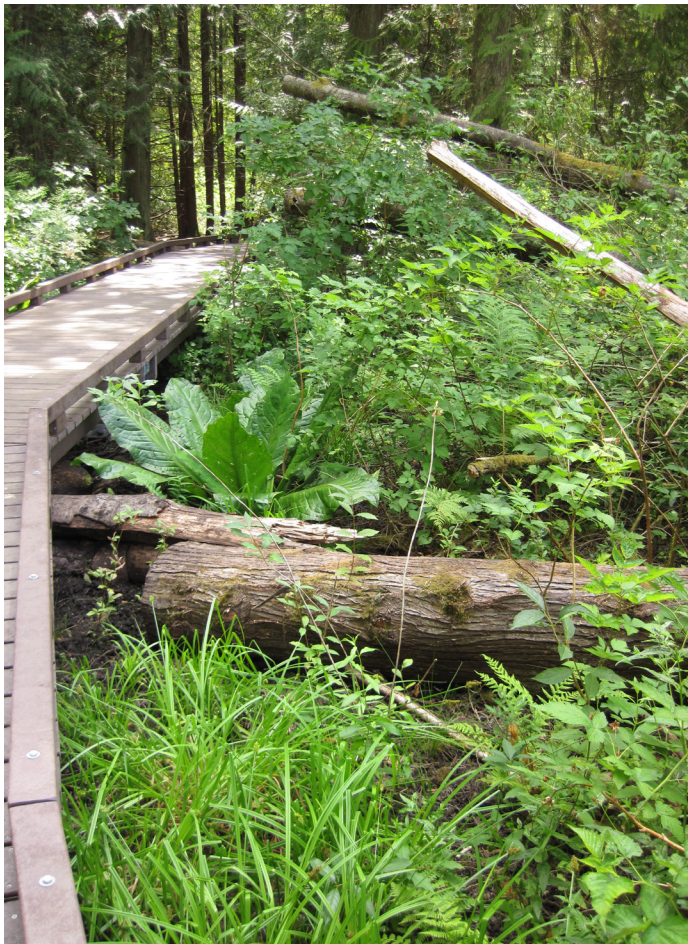
Sedges planted in the foreground and the surrounding plants are doing well in this wetland going through changes.

In the spring, I would like to plant more bunchberries and red huckleberry to the rotting logs, add a few shield ferns and small skunk cabbages to enhance the stream flow pattern, and transplant a few twinberry from the Front Meadow where there are too many currently, to the periphery here.

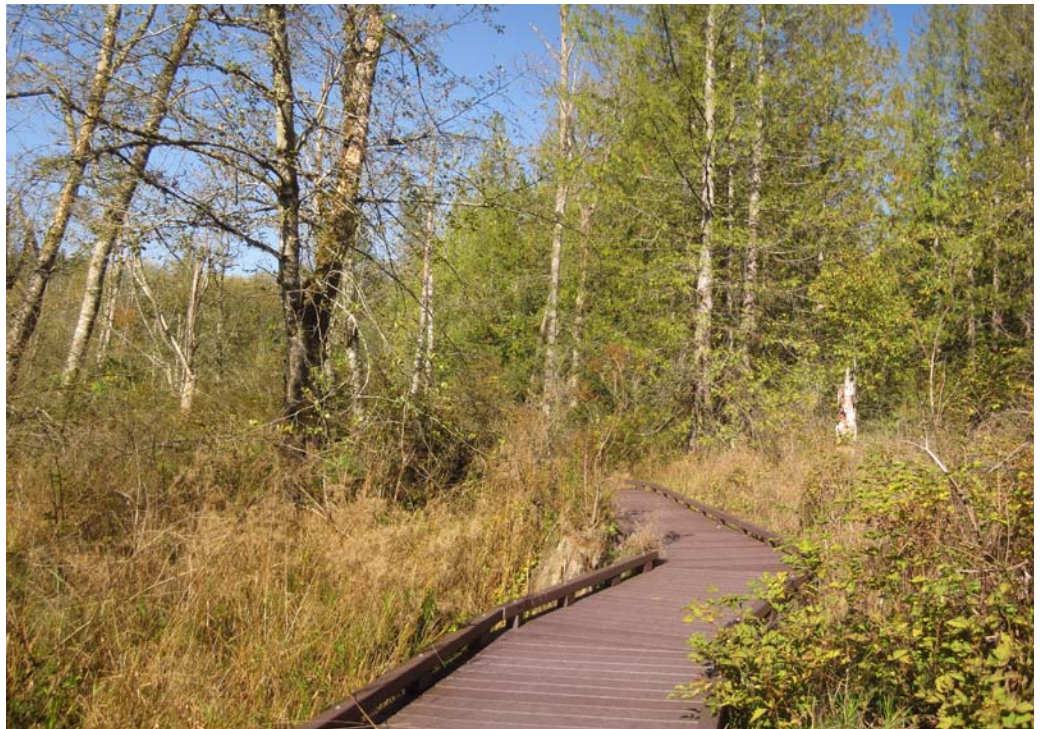
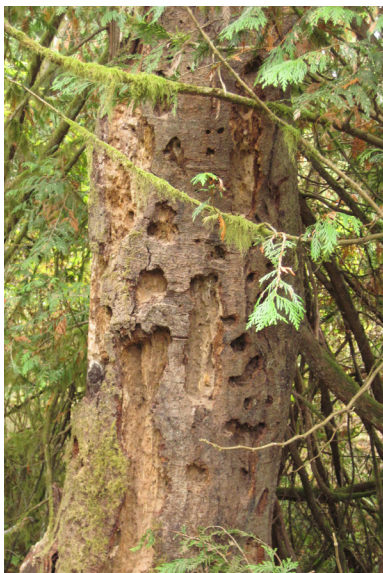
Below is the base of one of those tree snags which needs to be removed. This tree is probably over 40 feet tall and within reach of the boardwalk.

While this section of the site has great tree snags for the birds, there are two in particular that are hazards to the boardwalk space and need to be removed soon. One of them is located just southeast of the lower right corner of the photo above, next to the stream. The base of that tree can be seen in the photo (left). It is actually hidden from view behind another tall cedar so it can easily be overlooked from the boardwalk. This tree needs to be removed soon before it falls onto the boardwalk. The other tree is a large old red alder that is partially dead and also next to the boardwalk. In the photo above it appears to the right of the boardwalk in the background, but is actually on the northwest side of it near the curves. Even though there are some invasive plants below these trees and sedges to plant here, I will not risk the safety of volunteer groups at this point, by having them work under these two trees.

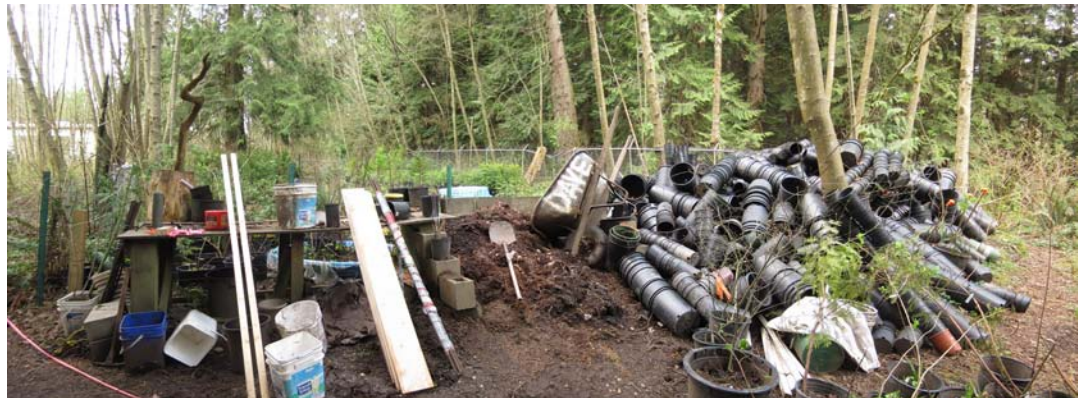
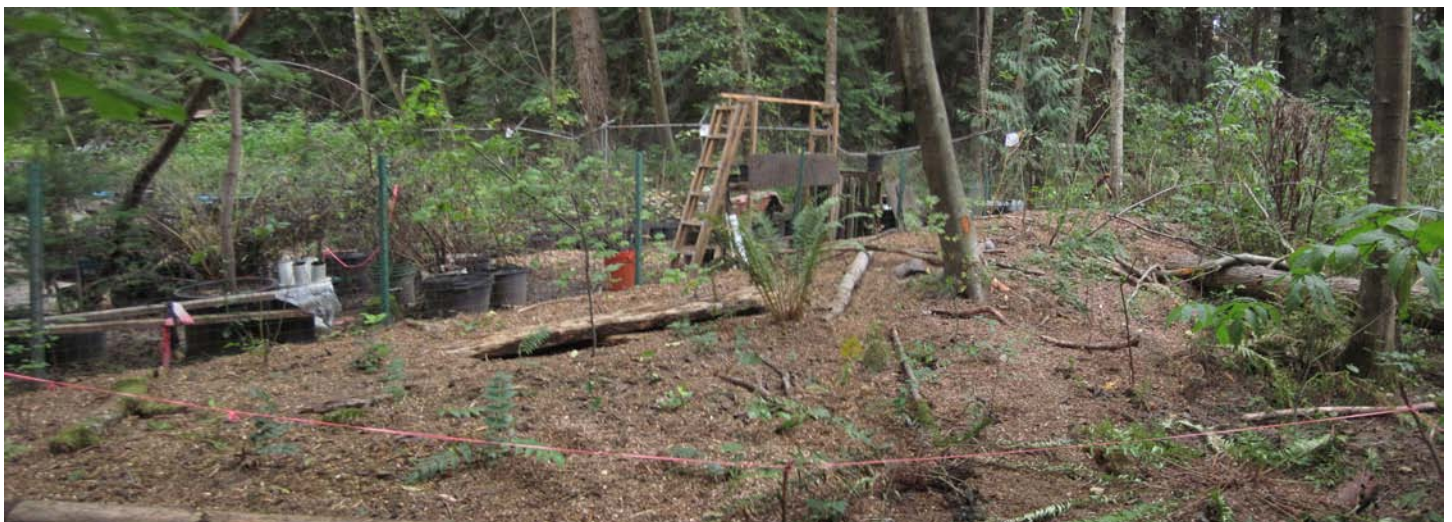
At right is a view of sectors 5-6 showing the plant nursery potting area in April 2014 looking northeast.

Above is the current view of the former potting area looking northeast from the same point after we replanted it. Moving the potting area north of the Plant Nursery is a big improvement, as debris was constantly piling up here and into the forest. It should fill in nicely if we stay off of it.

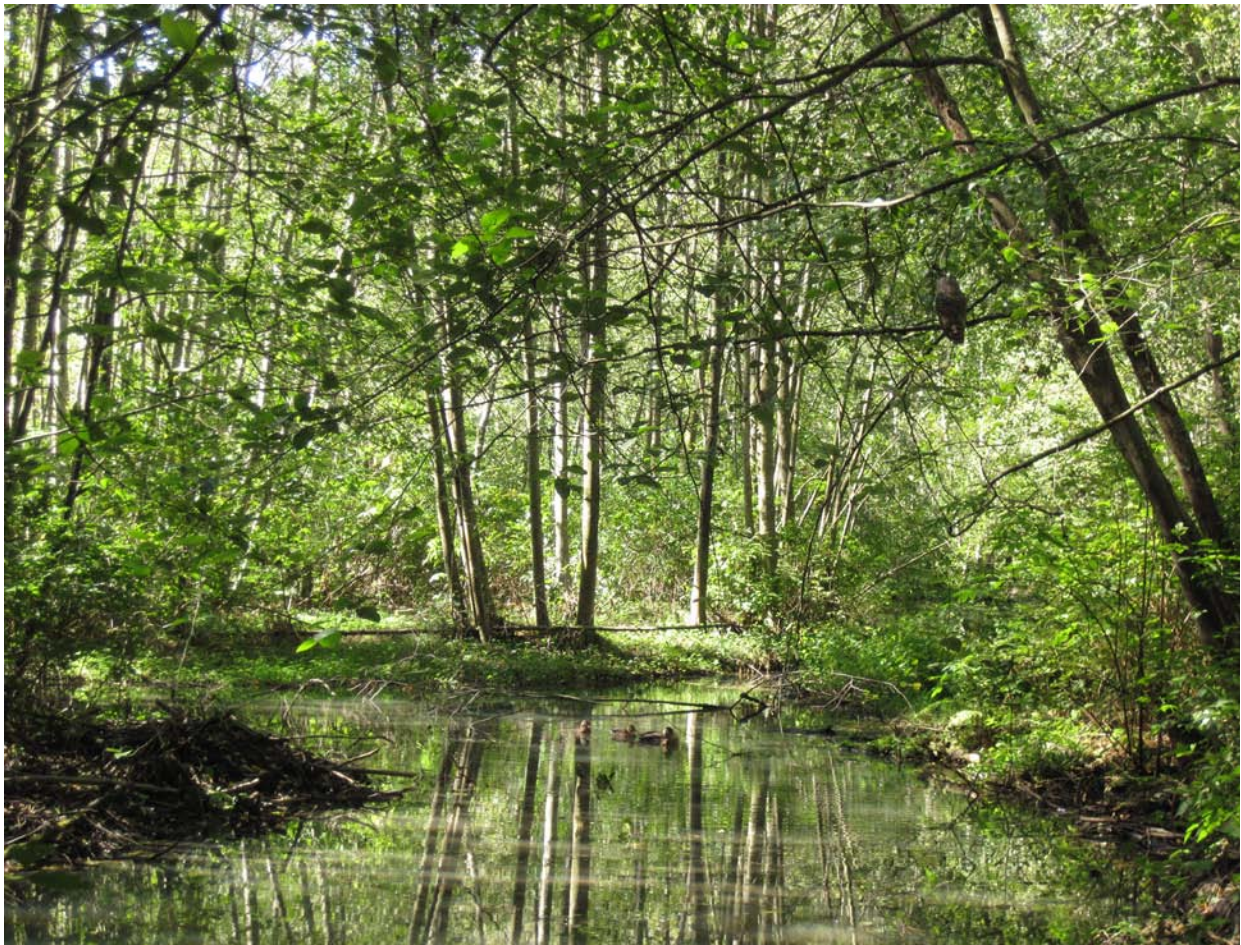
The Detention Ponds (below) are a beautiful site especially when the water isn't too murky. The ducks raise their ducklings here, while the owls watch from above. A visiting turtle hangs out at the log, and dragonflies make their rounds looking for food. In the photo (below) looking west, the Northeast Cedar Woods is on the left and extends into the background as a mounded peninsula. Along the shoreline in those two areas are mounds of mud and woody debris that the interns removed from the pond. At some point it would be great to plant sedges and skunk cabbages here to cover the mess and provide water filtration. I think this would be a good pond to try educational experimentation with phytoremediation techniques, and study water quality with regards to wetlands. In my last NWSC boardwalk project update (November 2014), I provided information on phytoremediation for those who want to learn more about it.

The Northeast Peninsula is located on the right in the photo (below). The shoreline of this peninsula was heavily invaded with nightshade and a 10 by 20-foot patch of *Vinca minor* (periwinkle), both of which we removed and replanted with Pacific ninebark, twinberry and red-osier dogwood. I have left a space open on the shoreline next to both the north and south ends of the bridge that crosses the Bioswale, to allow access to the pond for the mucking activity. I have suggested the interns or volunteers deposit the muck from the pond immediately where it can be used along the shoreline. Otherwise it creates extra work and a mess when left on tarps, as they did before, which I had to clean up. I would love to see sedges and skunk cabbages planted also in these areas along the shoreline after the pond muck is piled up here, but, as it is with the Trout Pond, I have no control over that activity so I will let Tom and his crew do it.

Notice how the owl at right enjoys watching the ducks in the pond below, in this beautiful view of the Detention Pond from the bridge looking west.

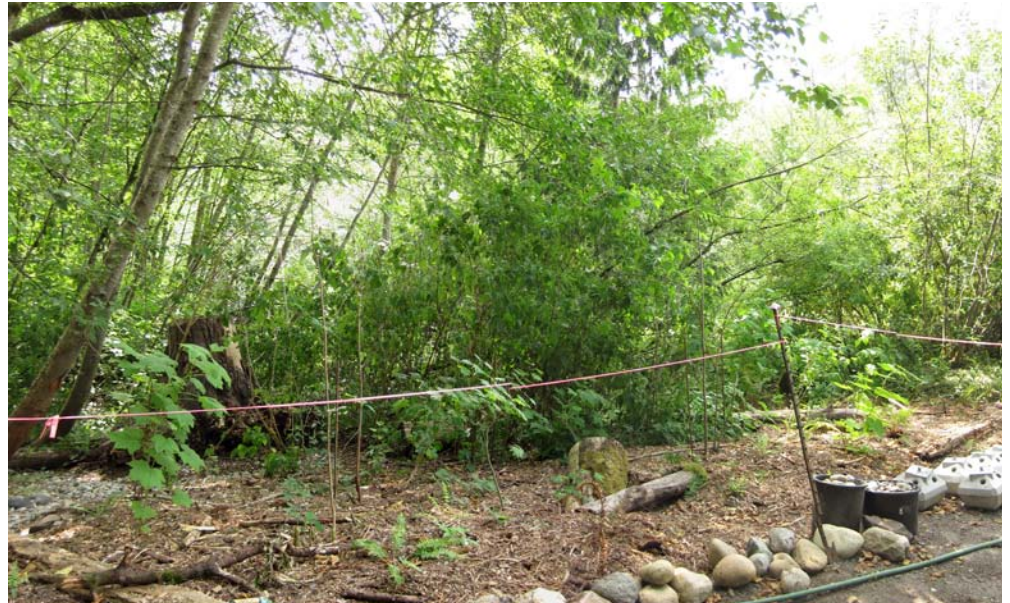
Larry and his crew added the gravel path with a drain underneath where water was accumulating on the route. Then a group of junior high students helped me put in the “dry creek bed” where the drain pipe ends east of the Detention Pond (lower left in photo). The shrubs and ferns we planted along the east entryway should fill in well while still allowing a glimpse of the Front Meadow.

These shrubs, recently planted, line the east entry to the boardwalk.

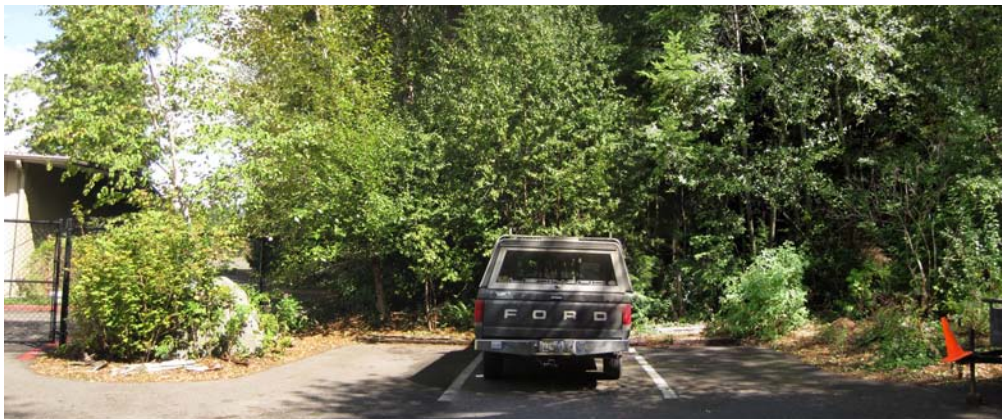
Legend has it Tom plans to get rid of the white car at right, but this legend is long-standing. It would be nice to open up another parking space, and have room to repair this back door ramp (with concrete?) That or put a “Room for Rent” sign on the car’s windshield and make a little extra money.

The photo (left) shows the paved AAS employee parking lot looking north.

The photo (below) shows the back door ramp made of loosely placed blocks that form a tripping hazard with its irregular surface.

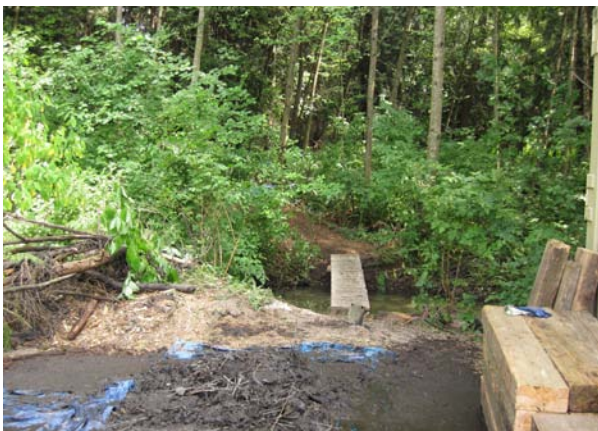
Dumping mucking debris where Larry was currently working to build the plant nursery bridge was poor planning and unnecessary extra work for volunteers.
